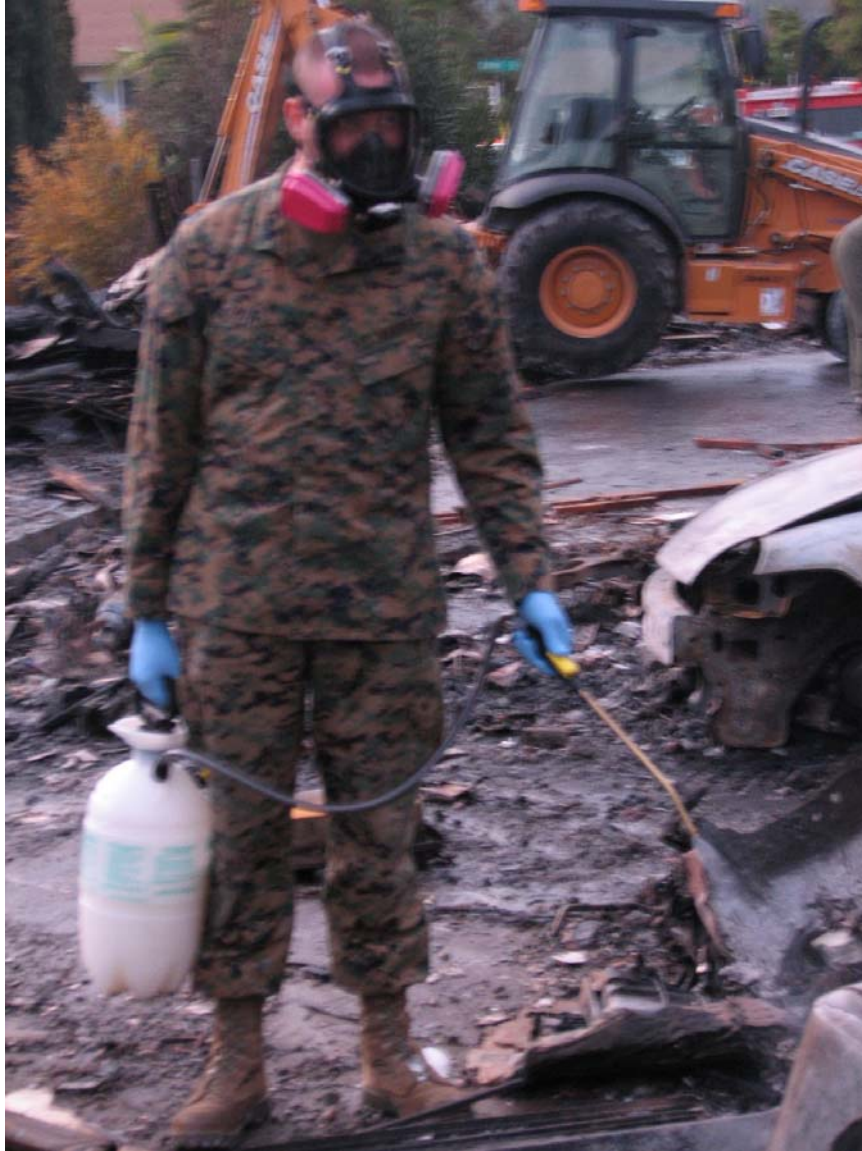
**Photograph 1: Emergency Responder spraying wax on wreckage to sequester carbon fibers. This activity is described in the Hazardous Materials Incident Report present in Appendix A.**

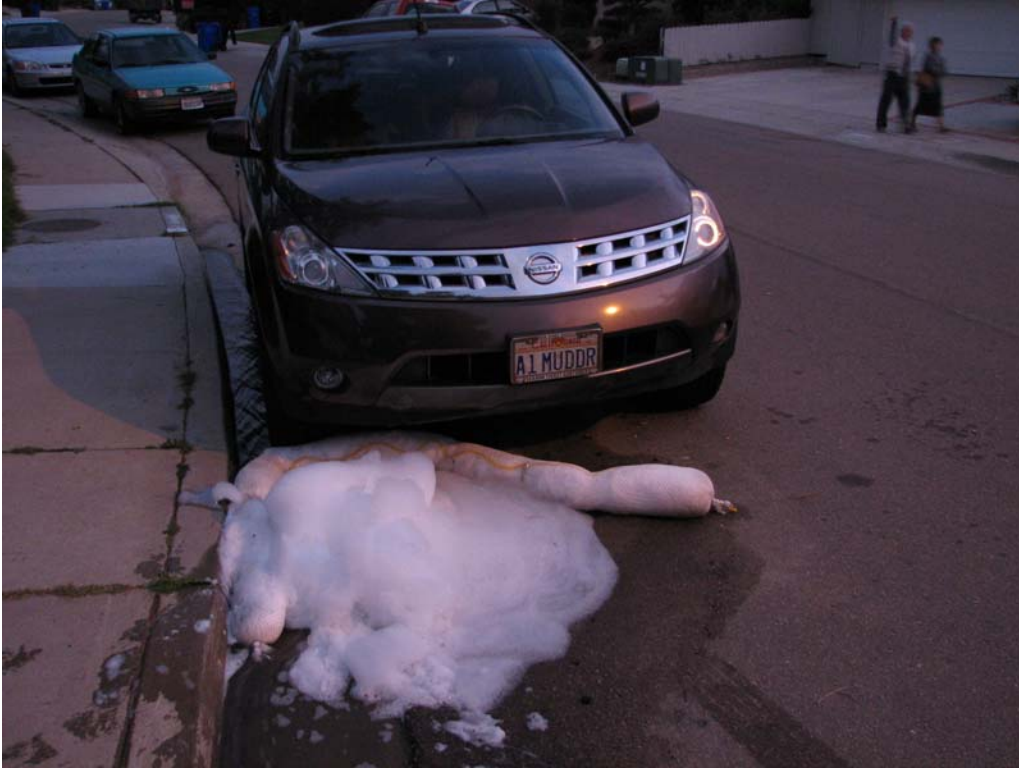
**Photograph 2: Hydrocarbon absorbing boom in storm drain down hill from the crash site.**

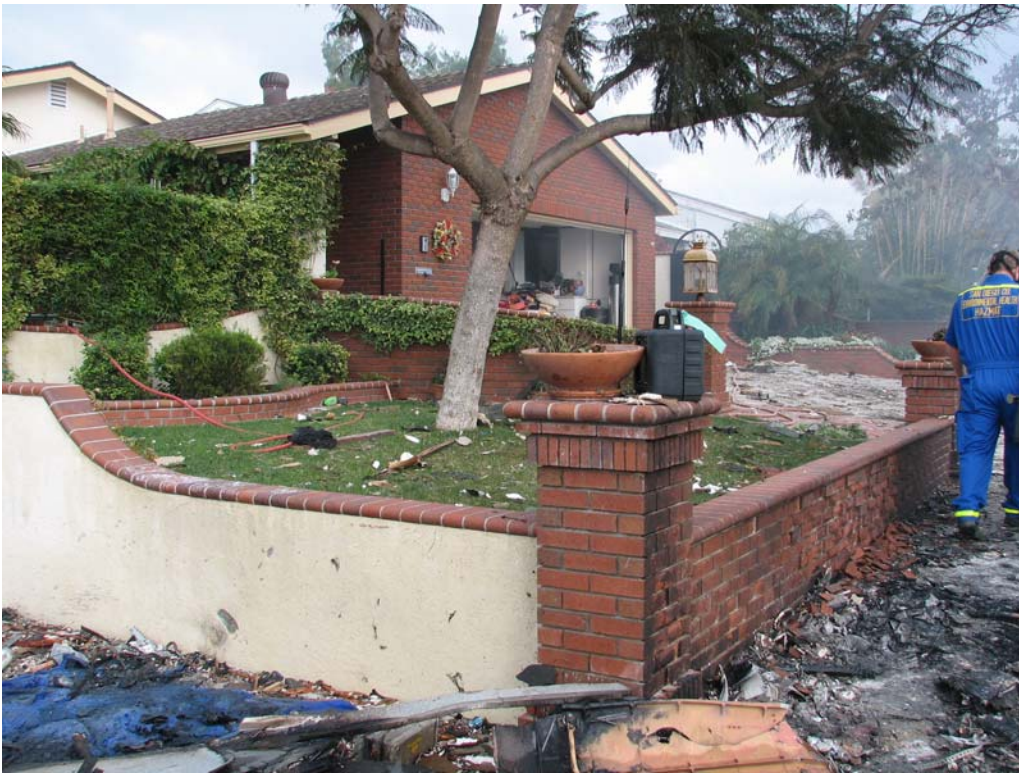
**Photograph 3: Property along Huggins Avenue near crash site. Photograph shows amount of debris that accumulated in front yards in the vicinity of crash site.**

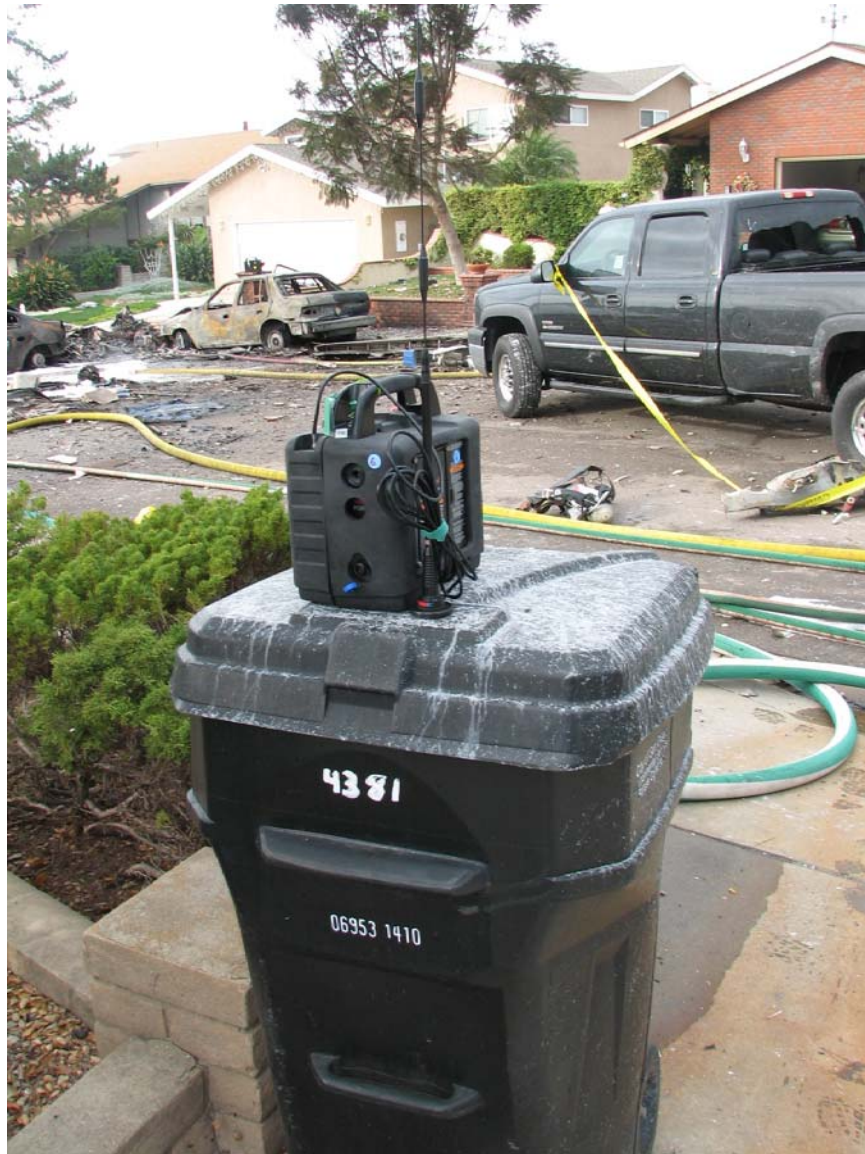
**Photograph 4: Air monitoring equipment during clean up activities.**
